MERRIMACK RIVER BASIN
WILTON, NEW HAMPSHIRE

SOUHEGAN RIVER WATERSHED
DAM NO. 10A

PHASE I INSPECTION REPORT
NATIONAL DAM INSPECTION PROGRAM

AUGUST 1979

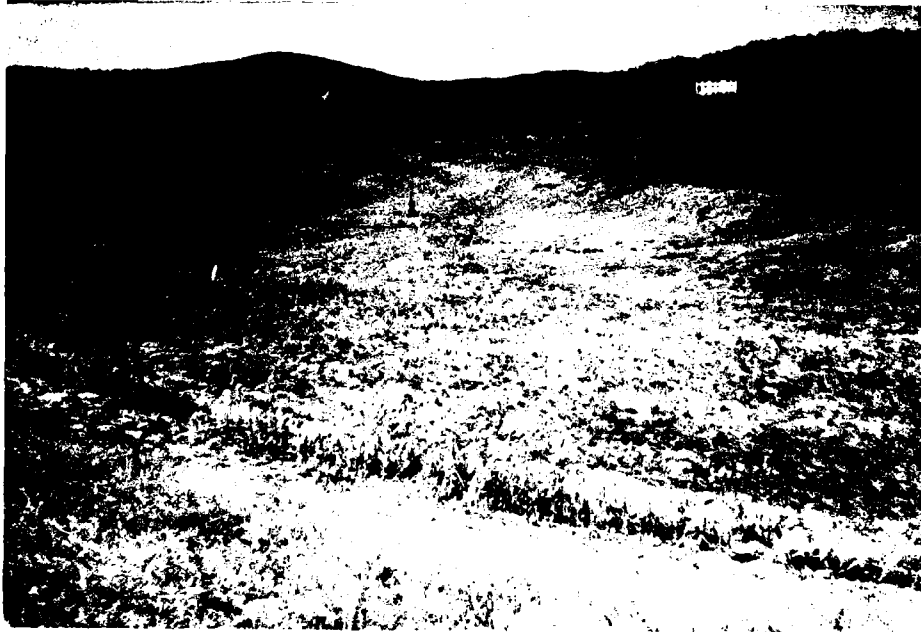
Overview from right abutment

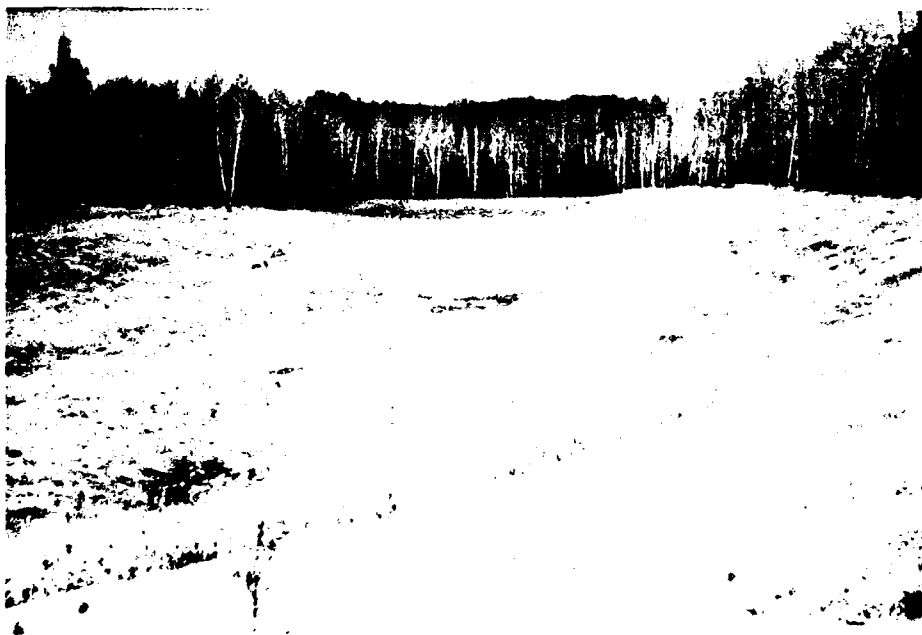
2. View of right emergency spillway channel
looking downstream

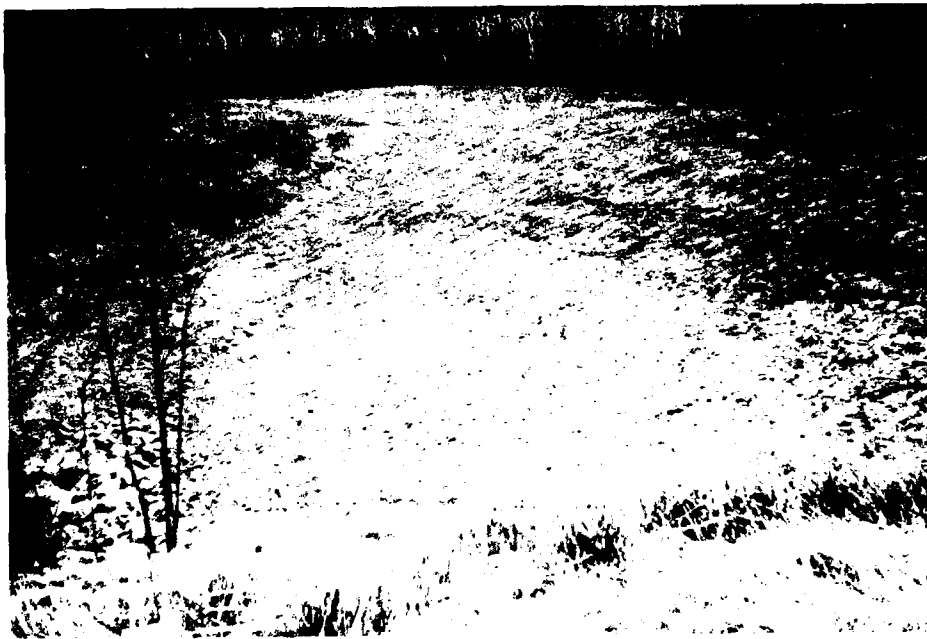
3. View of downstream slope from left side

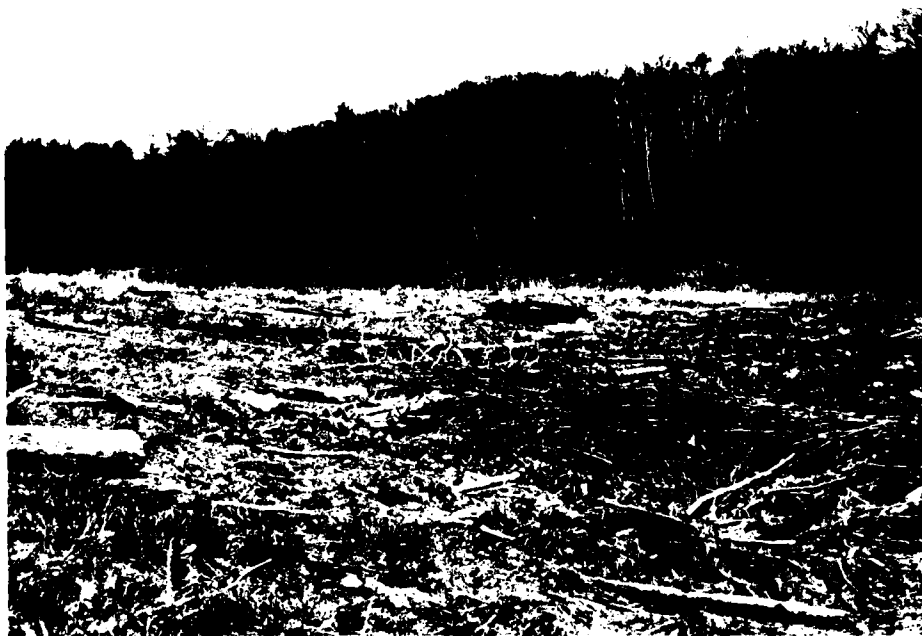
Some debris was found on the upstream slope of the embankment and tire ruts 4 to 6 inches deep in the crest of the embankment.

4. View of right upstream slope showing debris on the approach to the right emergency spillway

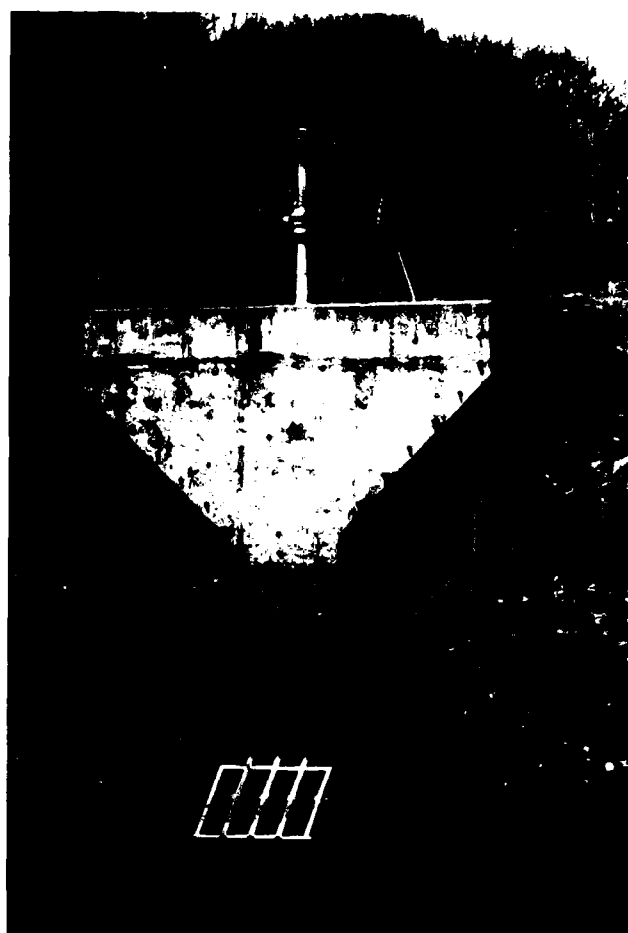
6. View of drop inlet structure showing low stage trash racks
